Water Softener Tank

Project: Concrete Tank Liner, Alexander Orr Water Treatment Plant, Florida

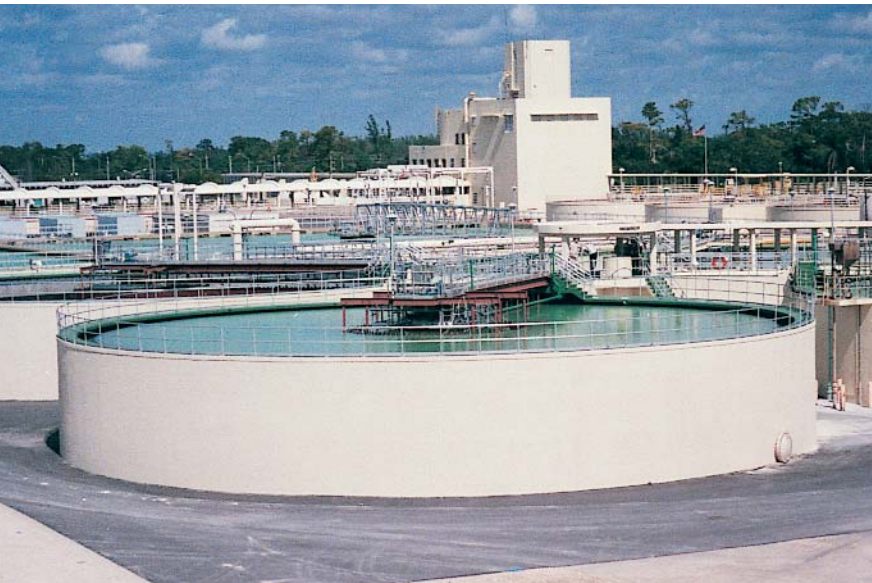
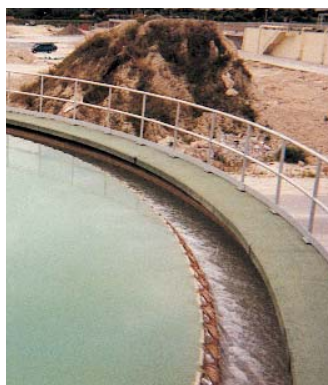
The maintenance staff at Alexander Orr Water Treatment Plant in Miami-Dade County was faced with water softener-related problems.

First, its softener was leaking, leaving unsightly efflorescence. A second issue confronted by the Miami-Dade Water and Sewer Authority-owned plant was extreme lime build-up on the softener's interior walls. Operators knew from experience that lime removal was a costly process and required hundreds of man hours to complete. Plant engineers searched for a product to provide a long-term waterproof

The application was straightforward. The concrete tank's interior walls were sandblasted and CIM 61 Epoxy Primer applied. After allowing the primer to cure for 12 hours, an air-assisted airless pump system was used to apply CIM 1061 over the primer. Following only an hour of set-up time, a second coat was applied.

At project's end, the softener had been coated, achieving a seamless and impermeable liner and restoring the softener's water-holding capability. The liner's rubbery surface also put an end to the lengthy lime removal process. Now, one man blasts the interior clean using a pres-

sure washer—a dramatic change from the time-consuming process necessary prior to the application of CIM 1061.
